Advisory Region Northern Gallatin

Forecast link: <u>GNFAC Avalanche Forecast for Wed Mar 15, 2017GNFAC Avalanche Advisory for Thu Mar</u> 16, 2017GNFAC Avalanche Forecast for Fri Mar 17, 2017GNFAC Avalanche Forecast for Sat Mar 18, 2017

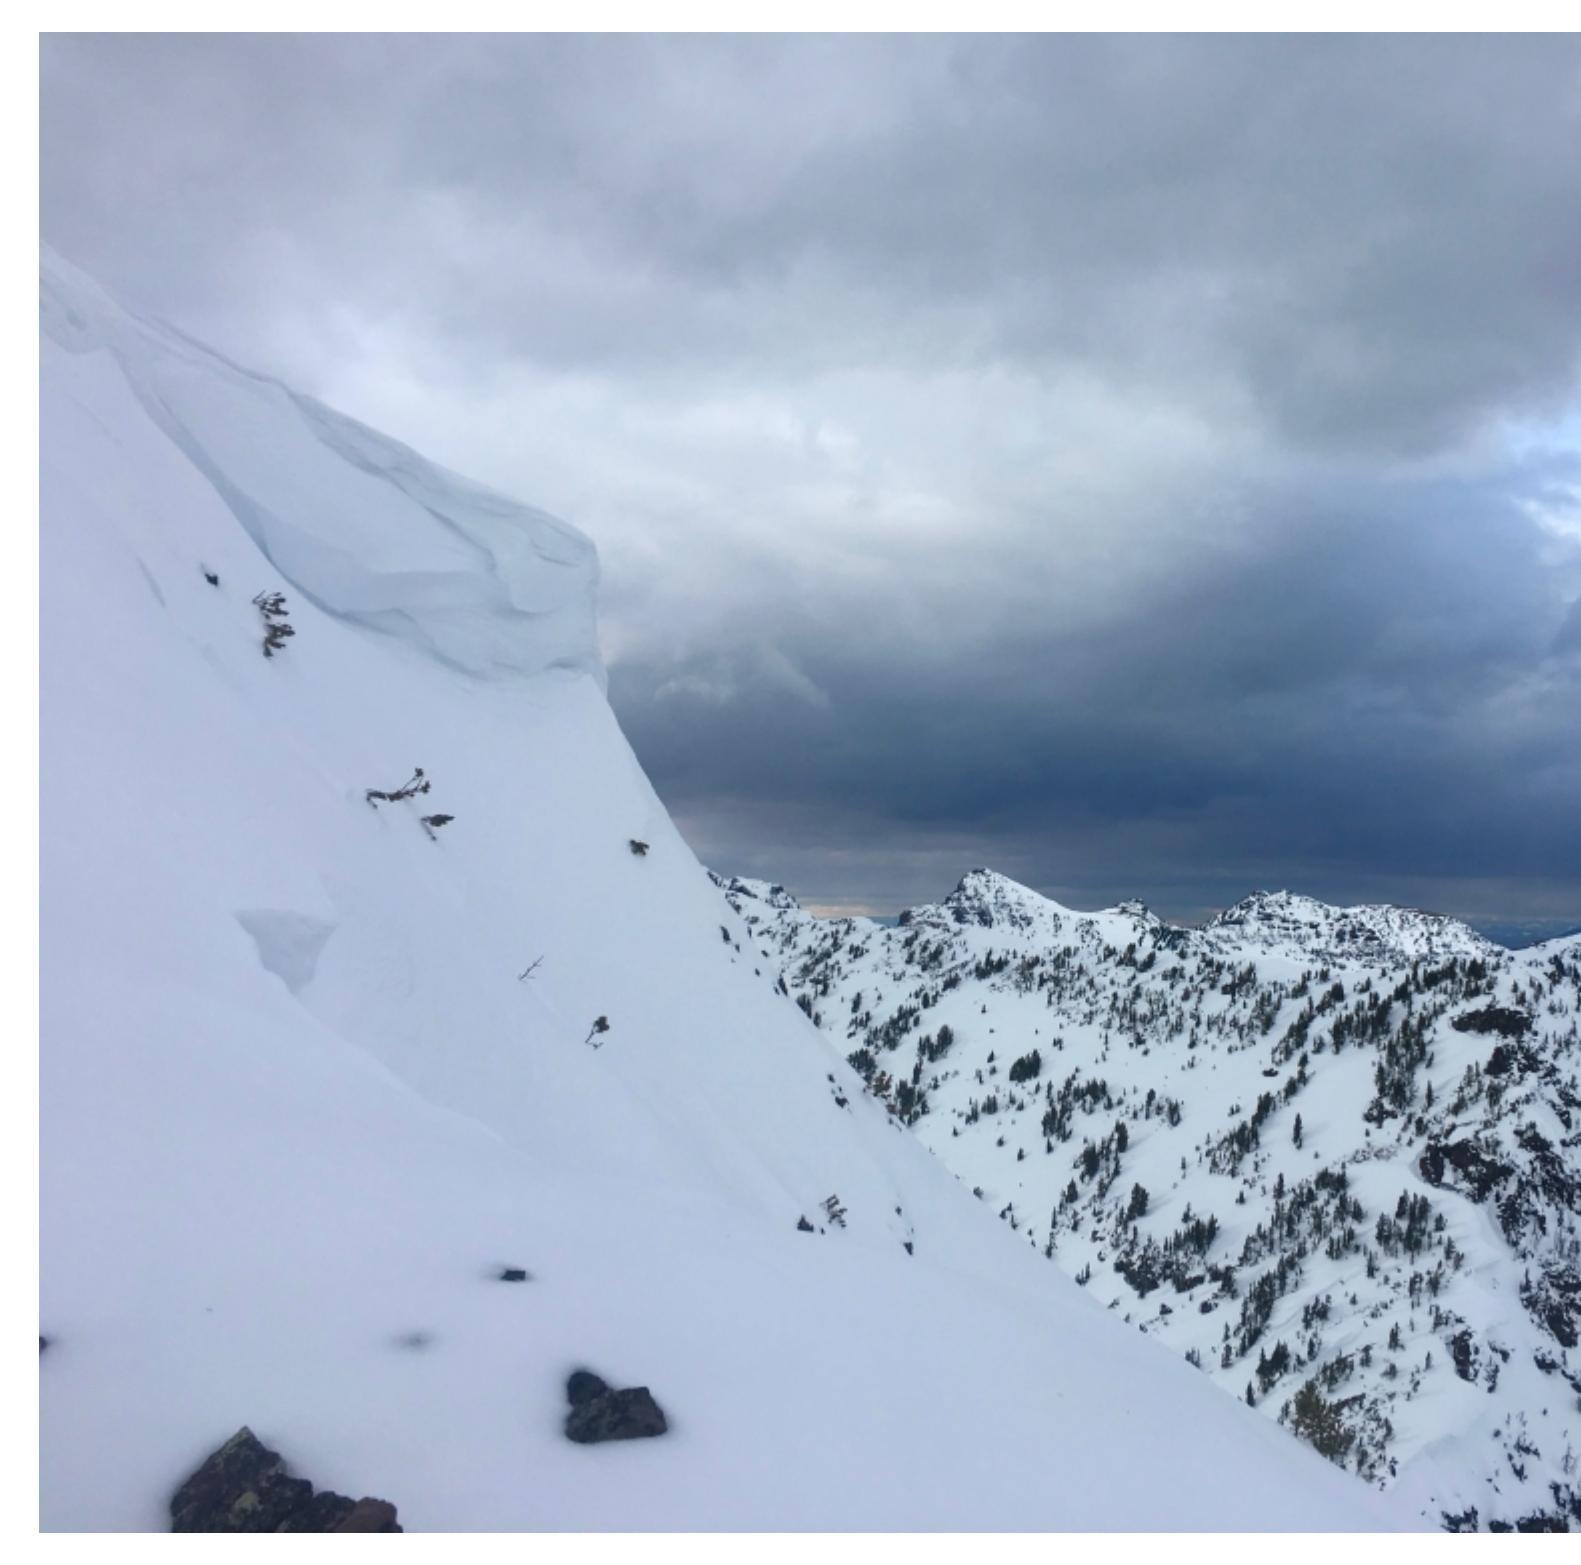
Cornices have grown large and overhang far over the edge. They are ready to break, especially with the warmer, above freezing temperatures. Photo: G. Antonioli
